**Installation Restoration Program
Phase II — Confirmation/Quantification
Stage 1**

**Dover Air Force Base
Dover, Delaware 19901**

*Science Applications International Corporation
8400 Westpark Drive, McLean, VA 22102*

**Final Report 9/84 to 6/86
Volume 1 — Technical Report**

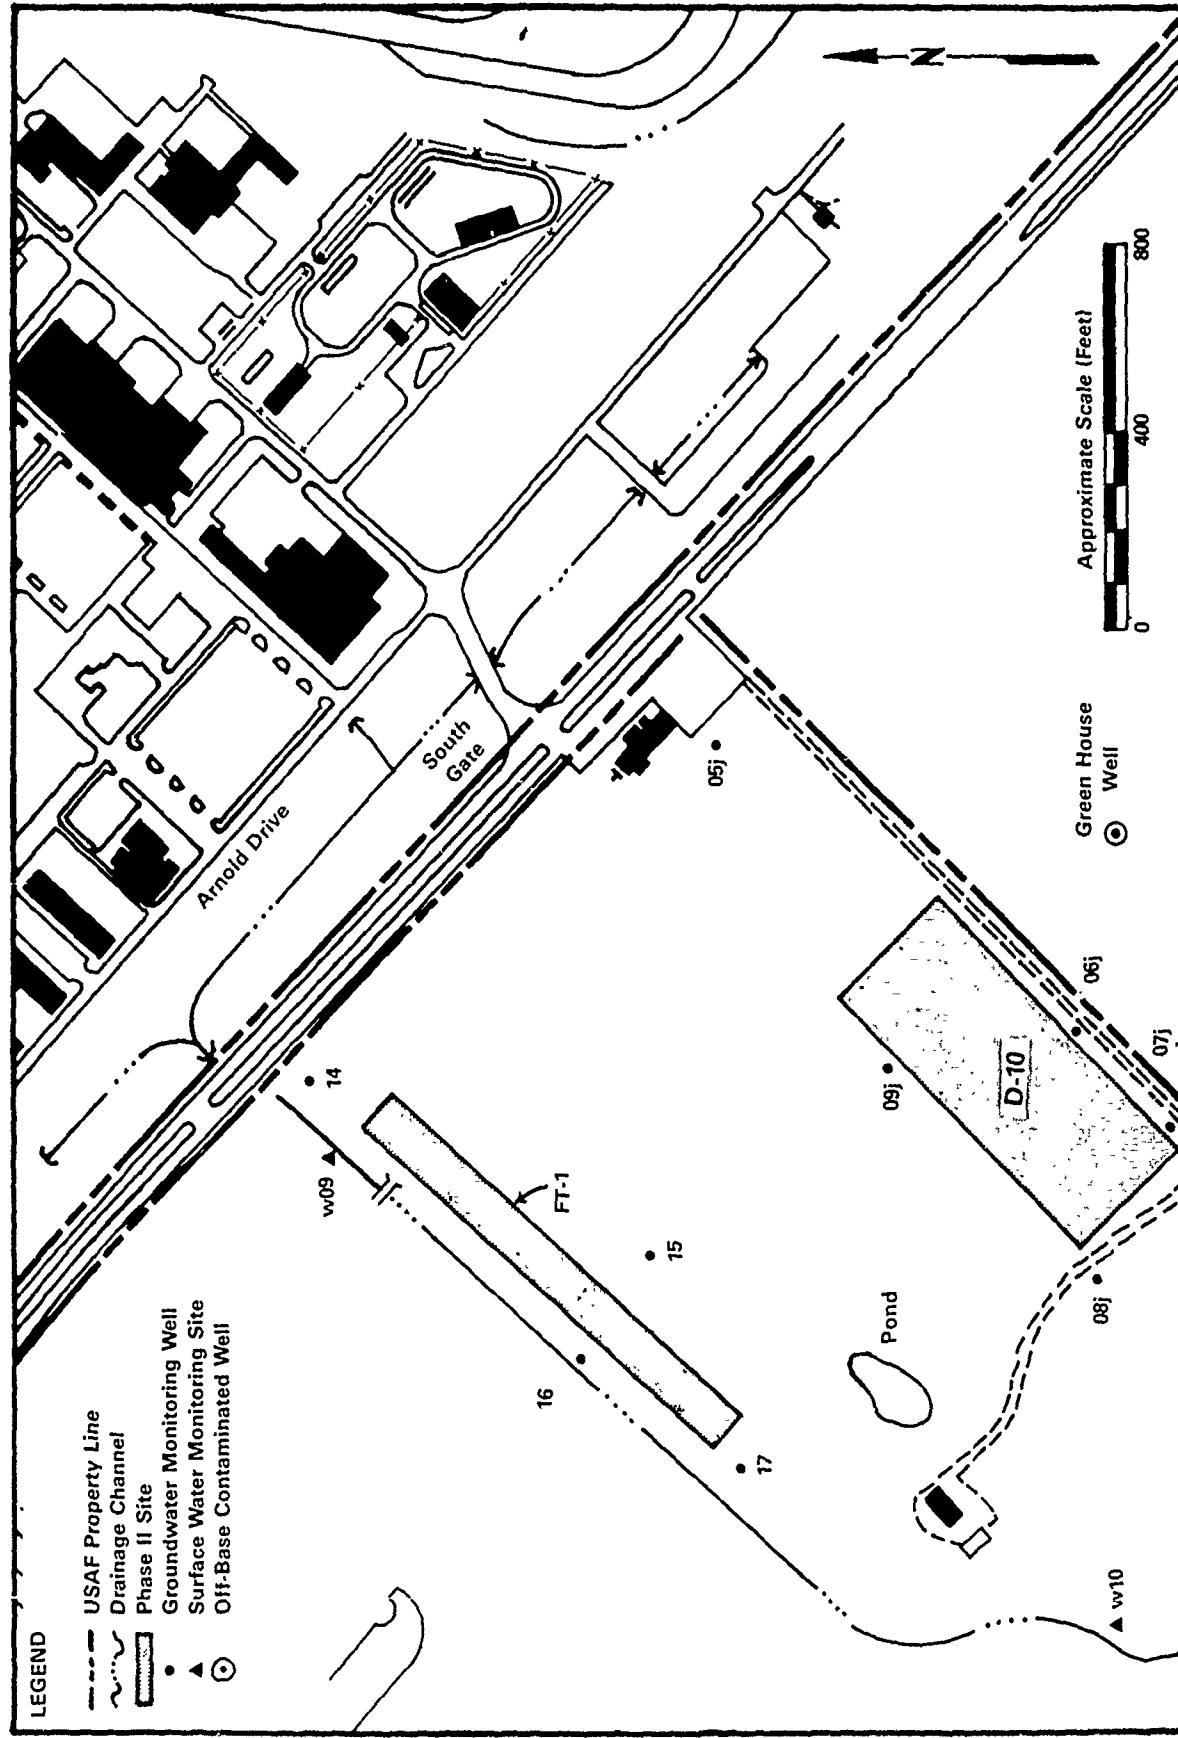
Figure 4-3. Monitoring Locations: Site D-10, Landfill and Site FT-1, Fire Training Area 1 (Golf Course Sites)

Groundwater samples were collected from five wells around Site D-10 and from four wells around FT-1. Figure 4-3 provides the locations of these wells. Wells 05j and 14 were potentially located to provide data on background water quality. Wells 06j through 09j were located around the estimated boundary of Site D-10 and wells 15, 16, and 17 were located around the estimated boundary of FT-1. Surface waters were sampled adjacent to FT-1 (w09) and downstream of FT-1 (w10). Samples from the surface waters and wells 14 through 17 were analyzed for arsenic, metals, oil and grease, TOX, and TOC; samples from wells 05j through 09j were analyzed for these same parameters plus cyanide and phenols.

5. TOX levels in all wells exceeded background levels (0.02 ppm) and ranged from 0.045 ppm at well 14 to 0.12 ppm at well 05j. Bailer wash and field blank samples contained TOX levels of 0.075 and 0.068 ppm, respectively. Because these levels are close to those found in environmental samples, the presence of TOX may not be representative of actual groundwater.

6. TOC levels in 05j (23 ppm) and 14 (16 ppm) were elevated when compared to concentrations detected in other golf course wells (1.6 to 6.6 ppm). TOC levels in these wells and wells 07j (6.6 ppm), 08j (5.3 ppm), and 15 (3.4 ppm) were greater than the highest TOC value reported (3.2 ppm) for the Columbia aquifer in Kent County, Delaware. Field blank and bailer levels were 1.8 ppm and 5.3 ppm, respectively. Therefore, the values present in all environmental samples except 05j and 14 may not be indicative of actual TOC contamination.

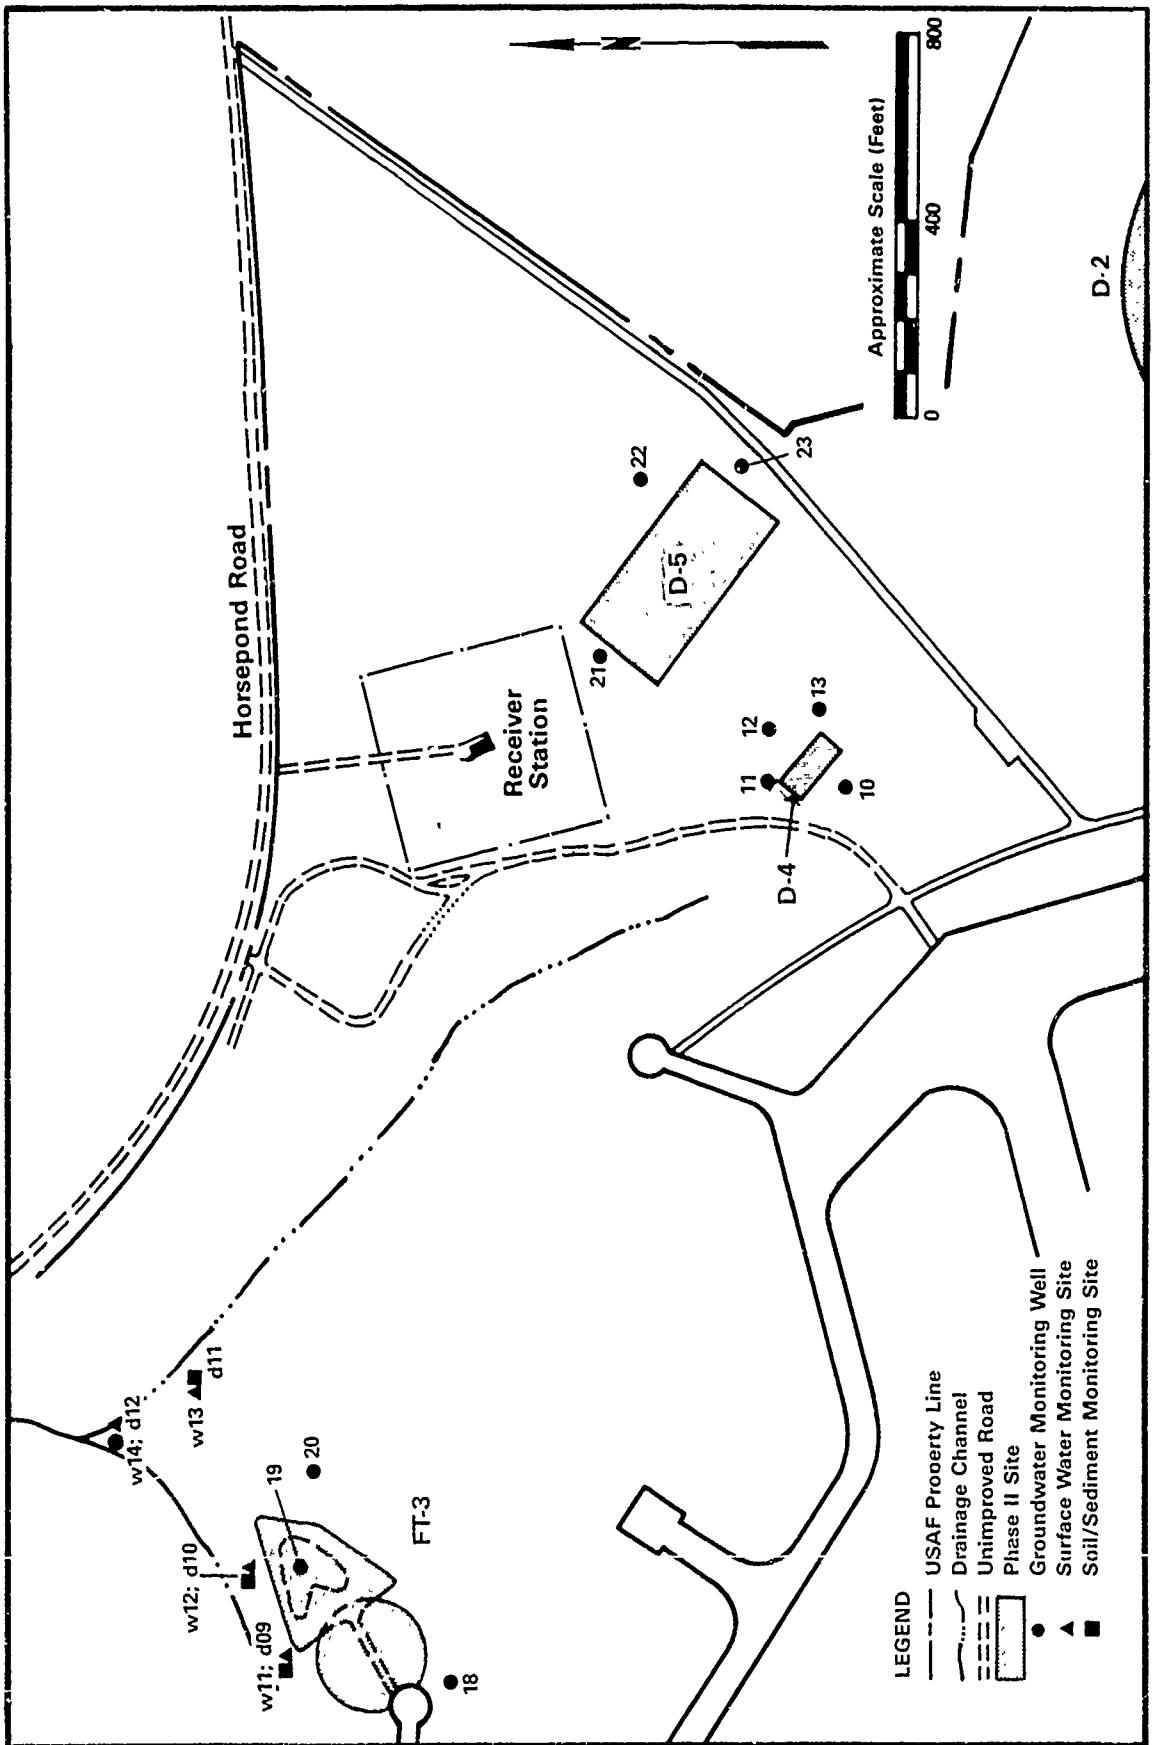
Figure 4-4. Monitoring Locations: Sites D-4, Liquid Waste Site and Site D-5, Landfill (Receiver Station Sites); and Site FT-3, Fire Training Area 3

1. Groundwater at Site D-4 contained VOCs with the highest total VOC concentrations found in wells 11 (5648 ppb), well 13 (1292 ppb), and well 12 (330 ppb). Wells around Site D-5 contained low levels (0.48 to 5.8 ppb) of VOCs. The positive identities of VOCs were not confirmed by either second-column gas chromatographic analysis or by mass spectroscopy.
2. Except for ethylbenzene and toluene, VOC concentrations in groundwater exceeded health criteria at both sites. Seven of the nine detected VOCs at Site D-4 exceeded health criteria while only one VOC of the four detected at Site D-5 exceeded health criteria.
3. VOCs were detected at low levels (less than 1.1 ppb) in the field blanks and bailer washes. The same VOCs were detected in both samples, but levels in the bailer wash were slightly less than the field blank.

Groundwater samples were collected from three wells (18, 19, and 20) around Site FT-3 (Figure 4-4). Well 18 is located upgradient of the site, well 19 is located between the site and a small stream north of the site, and well 20 is located between the site and a small stream northeast of the site. The direction of groundwater flow in this area is towards the northeast.

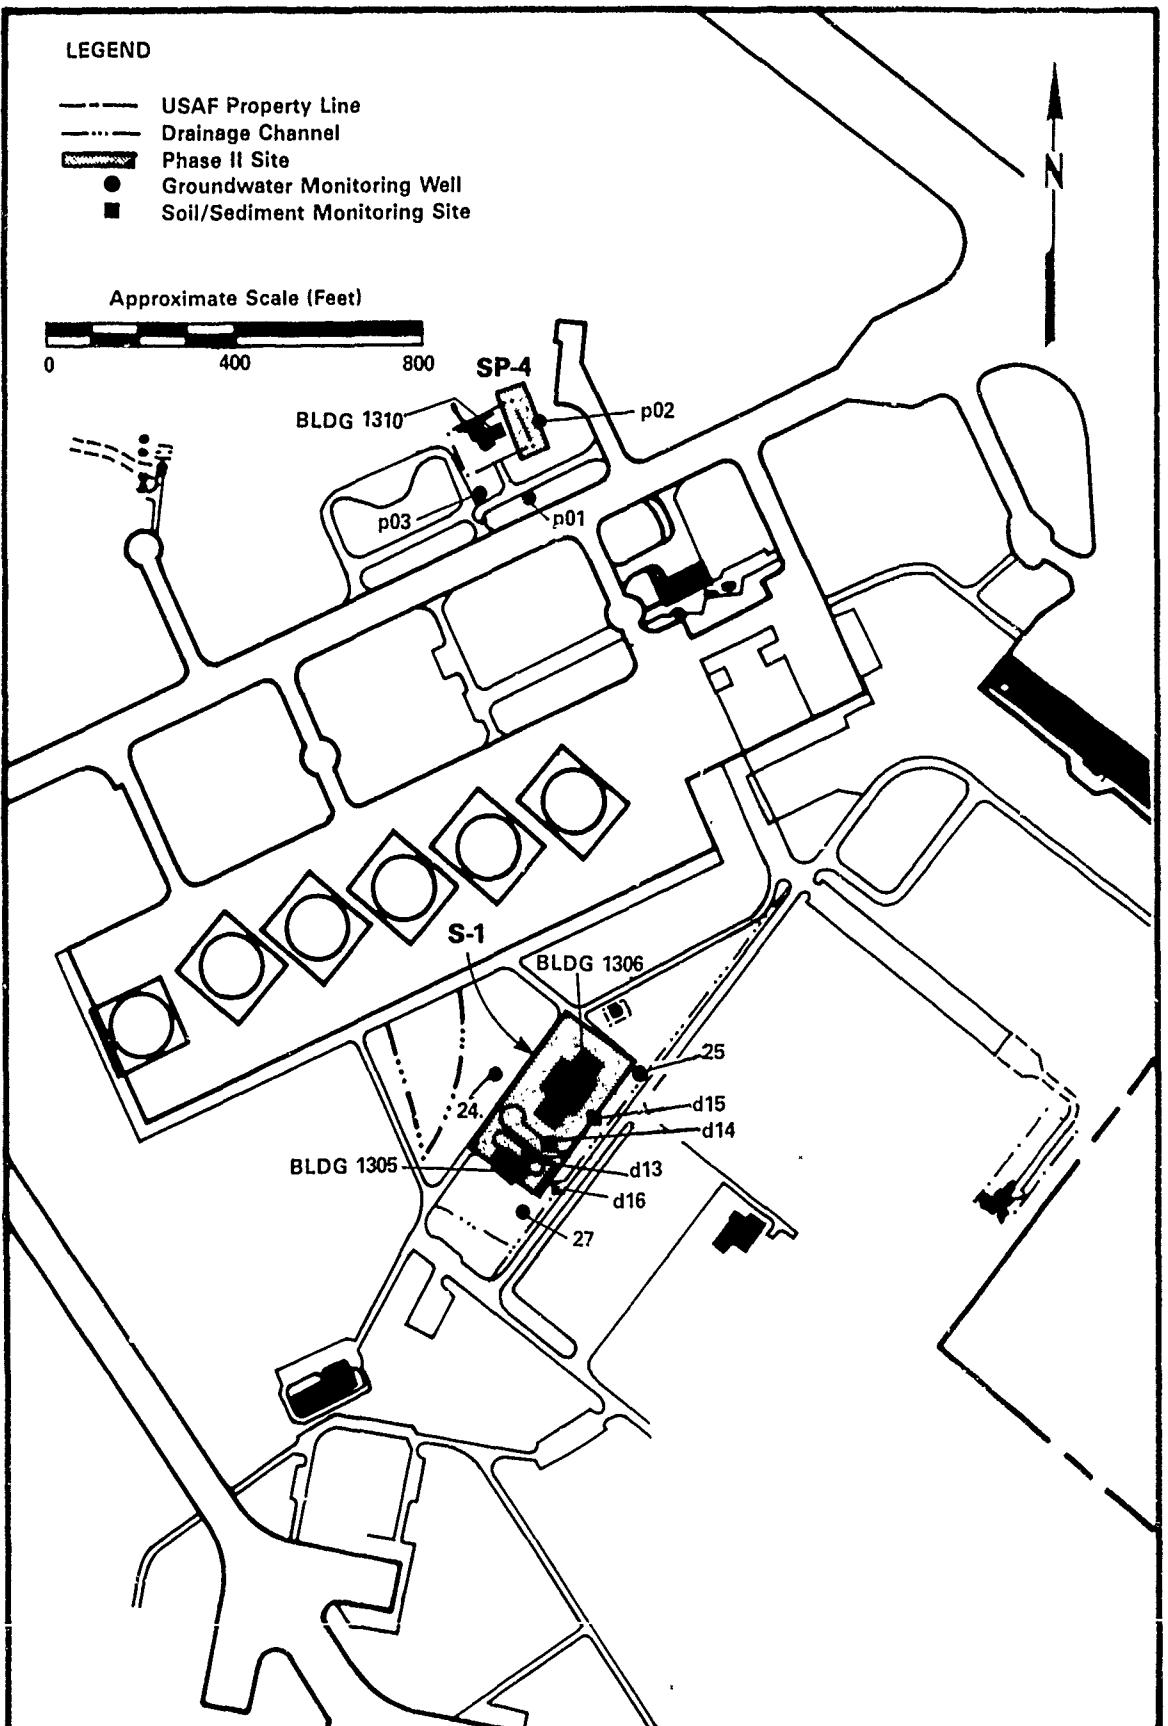
Figure 4-5. Monitoring Locations: Site SP-4, JP-4 Pipeline Leak
and Site S-1, Hazardous Waste Storage

Groundwater samples were collected from three well points (p01, p02, and p03) around Building 1310 (Figure 4-5). Groundwater flow directions for this site could not be determined from the Stage 1 results because water levels in the well points fluctuated widely (e.g., water levels in p01 increased to +15.04 ft MSL from +12.7 ft MSL over 1 month, while the water levels in the other two well points decreased over the same time period). The site is located close to the estimated position of the groundwater divide, therefore, flow could be towards the north or south (Section 2.3.6).

Groundwater samples were collected from three wells (24, 25, and 27) around Site S-1 (Figure 4-5). Groundwater elevations differed slightly between these wells (+10.1 to +9.76 ft MSL). Direction of flow based on regional data appears to be south towards the St. Jones River (Section 2.3.7). Well 24 is located northeast of the basins and is not downgradient of the site, so this well provides background water quality information. Wells 25 and 27 were located next to the storage pads outside of Buildings 1305 and 1306 and well 25 is upgradient of well 27.

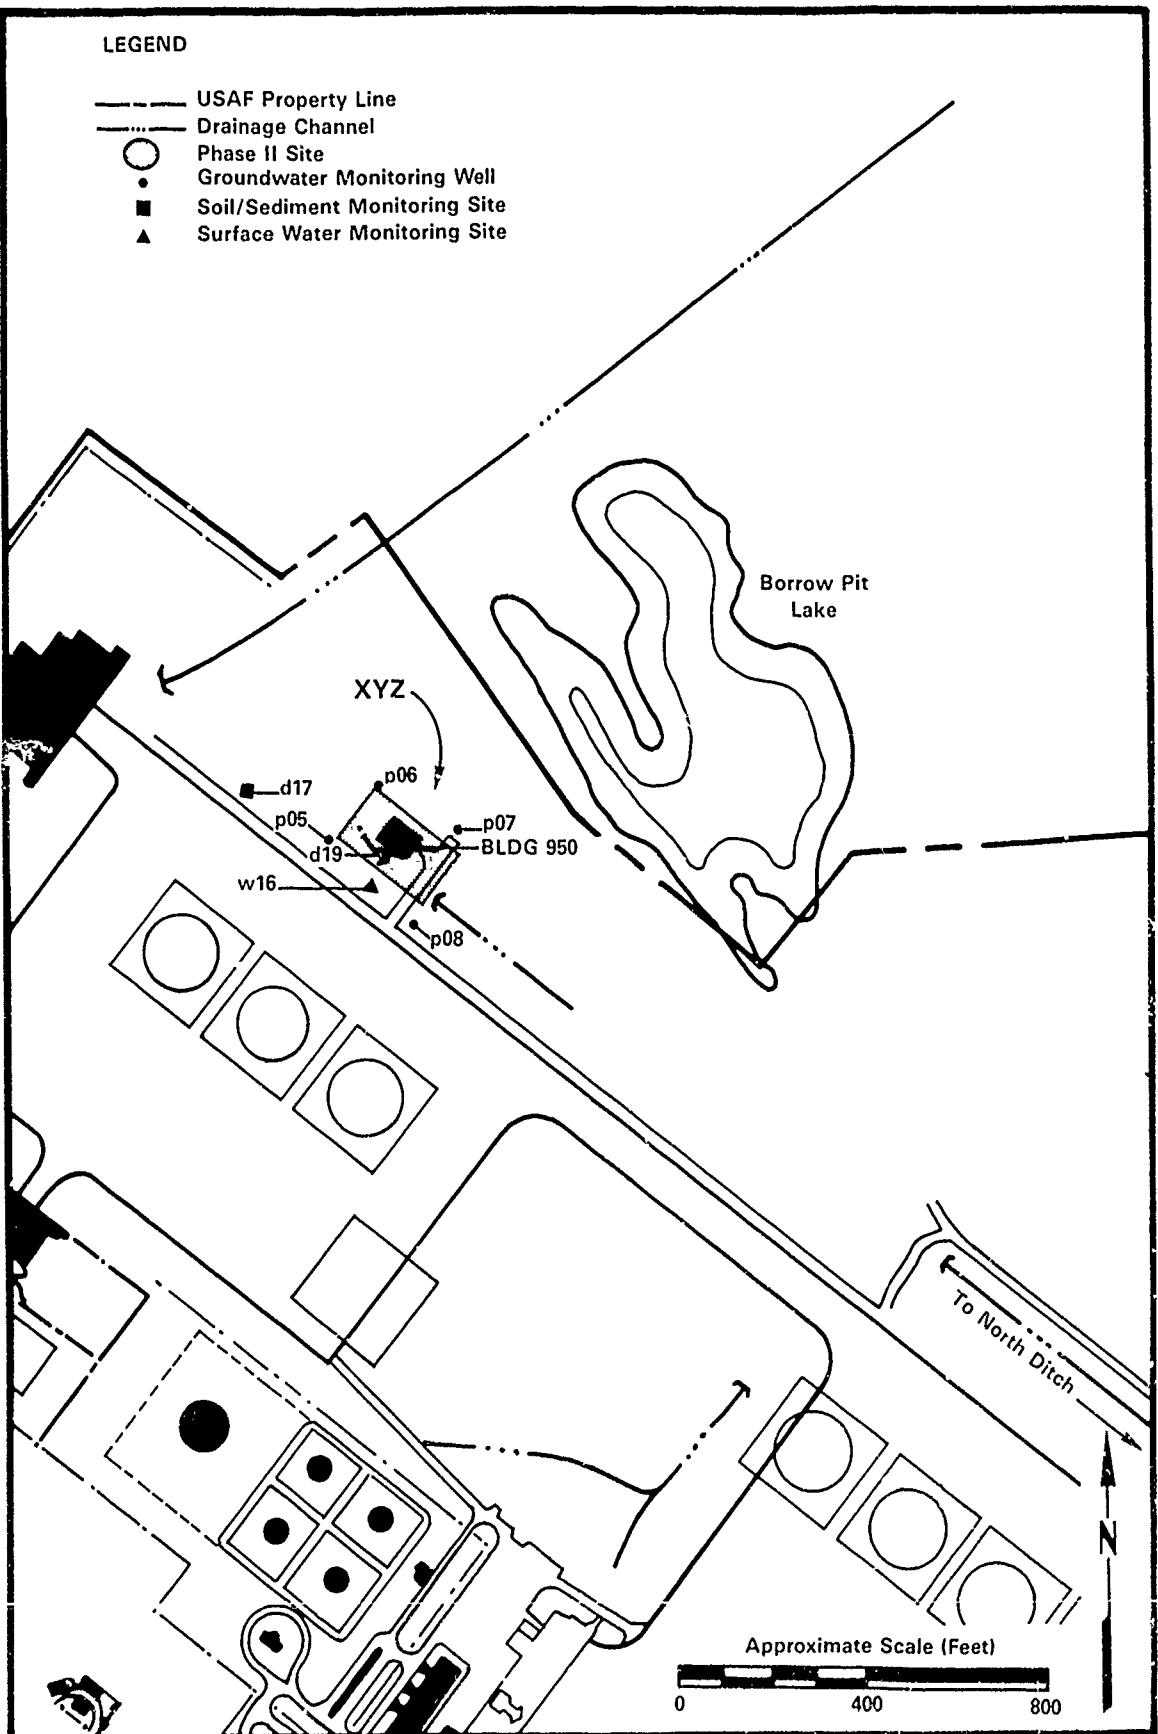
Figure 4-6. Monitoring Locations: Site XYZ, Fuel Pump Station

Groundwater samples were collected from four well points (p05, p06, p07, and p08) around Building 950 (Figure 4-6). The site is located along the groundwater divide, so groundwater flows away from the site towards the southwest and northeast (Section 2.3.8). One surface water sample (w16) was collected from a manhole southwest of Building 950. Sediment samples (d17 and d19) were collected from two manholes between the hardstand and Building 950. All samples were analyzed for oil and grease and TOC.

1. Oil and grease was not detected.
2. A TOC level of 29 ppm was detected in the water sample.

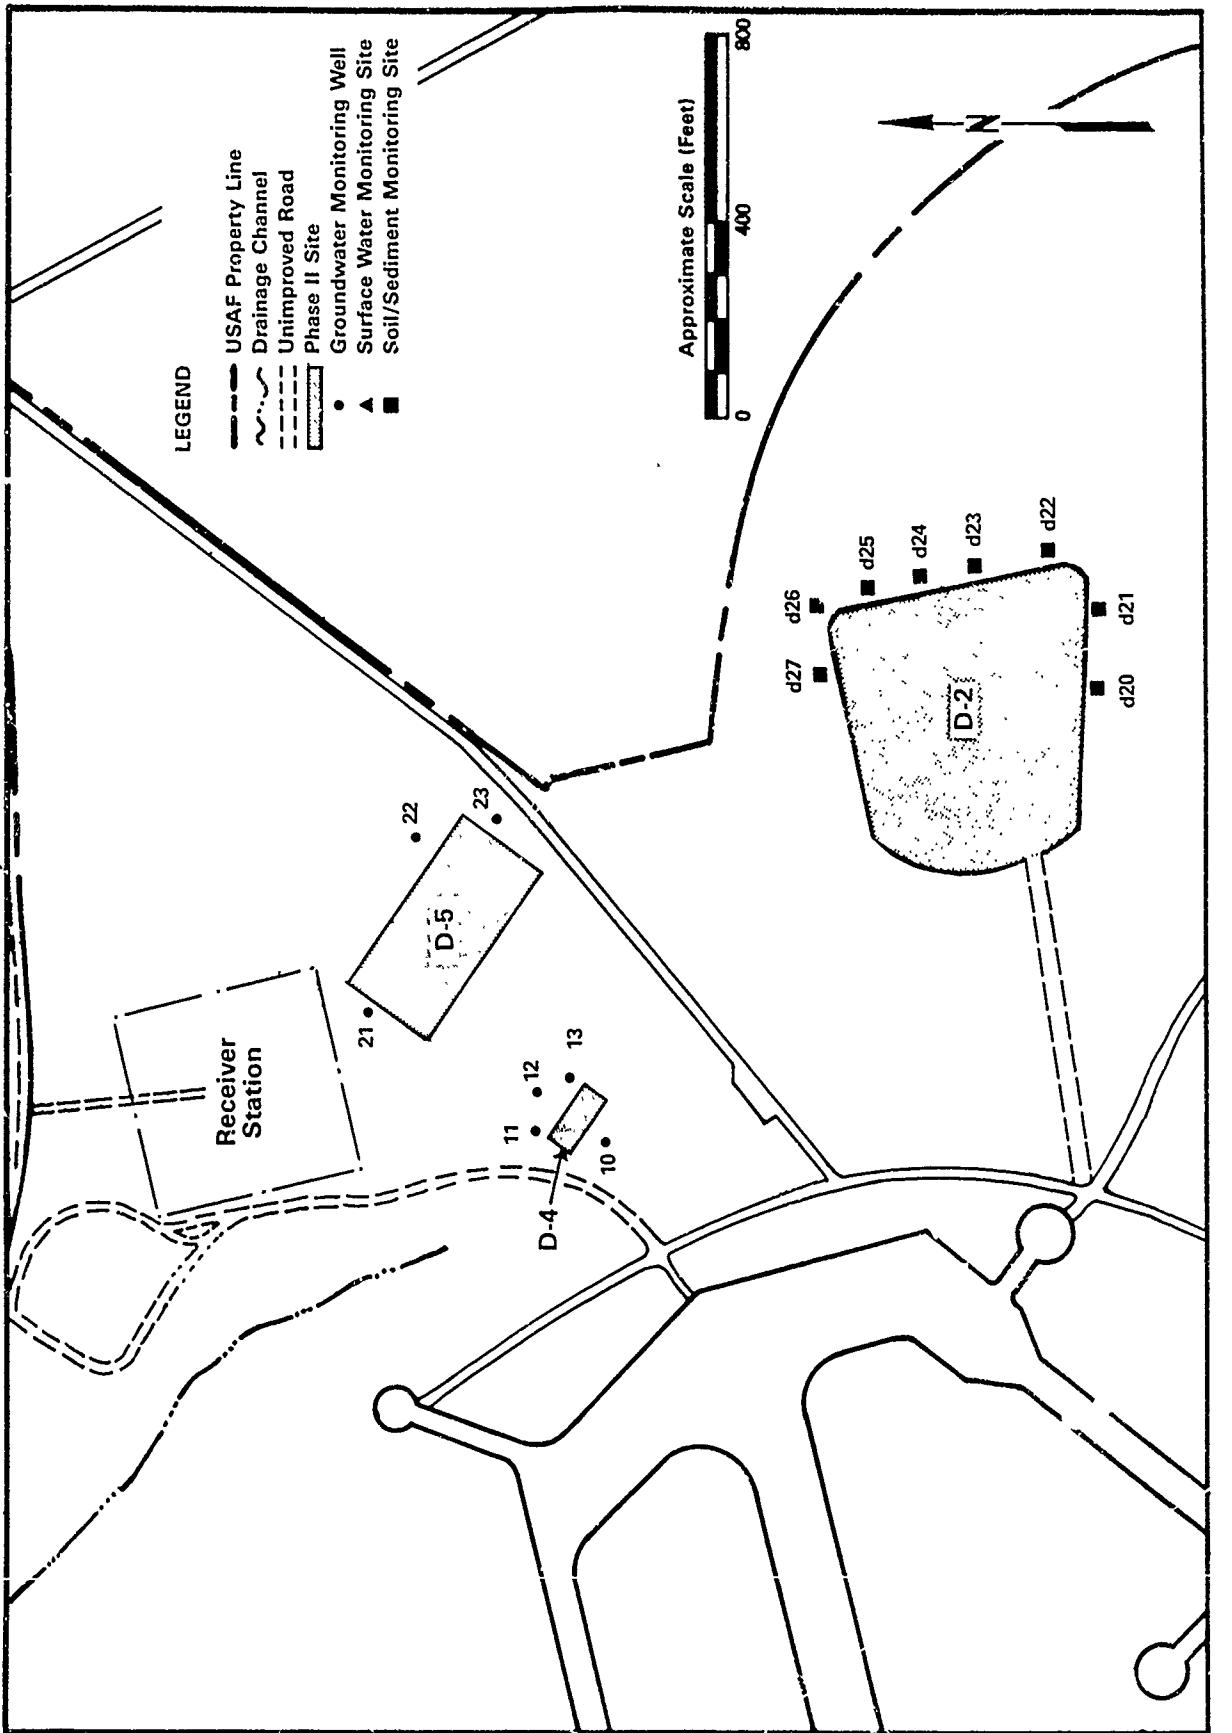
Figure 4-7. Monitoring Locations: Site D-2, Rubble Area

Eight soil samples were collected from around the toe of the landfill where runoff would be expected. Locations of sampling stations are shown in Figure 4-7. Soil samples were analyzed for arsenic, metals, oil and grease, TOX and TOC.

1. Metals were detected in all soil samples, with chromium, copper, mercury and cadmium being detected at levels less than background values.
2. Levels of arsenic (27 to 48 ppm) in all samples exceeded the highest background levels (2.7 ppm) reported for the Maryland and Delaware Coastal Plain.
